Architectural Impact Assessment for 'The Grove' at 27 Blackburrow Road, and adjoining newer properties in Mills Circle, Hayfields, Pietermaritzburg

June 2010

Prepared for: Terratest

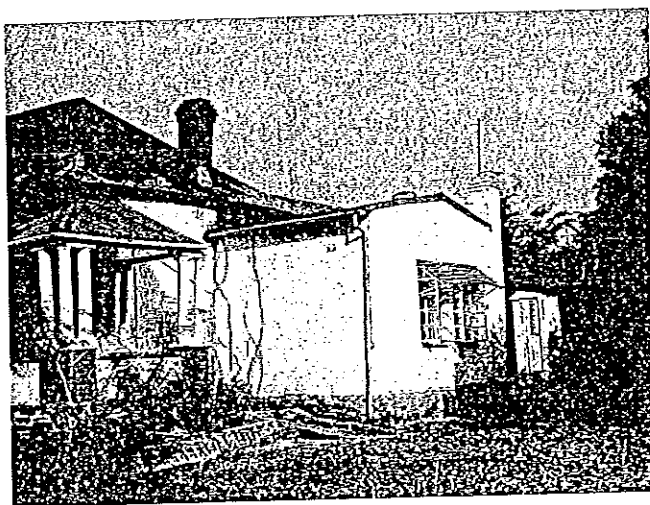
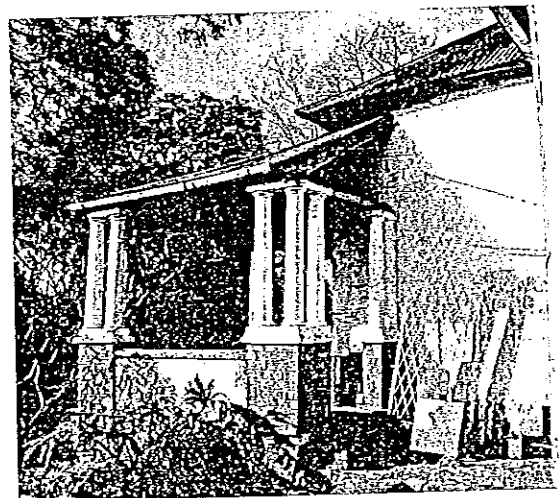
Figs 10 and 11: Approach from Mills Circle showing later addition and entry to veranda  
The construction of the veranda is a masonry balcony wall on a shale base. In places, the latter has

begun to collapse, creating bulging in the general line of the wall. Particularly of concern is the area around the main staircase, where rotational movement is pushing the pediment and its columns forward. This has resulted in large gaps in the base of the staircase, (Fig 16) and spaces which have been subsequently filled with interstitial pieces of timber, in the roof structure above (Fig 18). The collapse of this part of the veranda, in isolation of the other areas where the base shale is bulging out, could be as a result of the extra weight of the pediment and its associated columns as well as the increased ground water as a result of the leak to the reservoir to the rear as previously mentioned. Fig 14 shows the gap between the roofing and the pediment. This collapse of the external veranda wall is extended into structural failure in the flat arches over the French doors which lead from the veranda into the erstwhile reception rooms (Fig 17). These walls too are of shale with mud mortar pointing. There is some evidence of internal cracking.

Repairing the house would be costly. In addition to underpinning of the veranda, and propping up of the occasional collapsing arch, the roof has not had any maintenance for many years, and the timberwork on the verandas is evidence of this. Some gutters are held on by rope, and generally all repair has been reactive rather than proactive. Many of the chimneys are in need of rebuilding. Shale work on the front elevation is bursting at ground level.

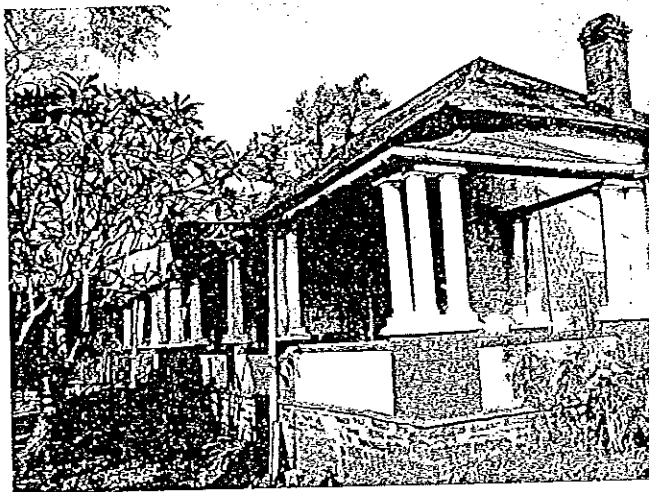
Other maintenance issues that have led to major indicators of failure is the shocking condition of the timberwork to the veranda. It would seem that the truncated Tuscan columns were a later addition, replacing earlier timber columns. This change, and the dearth of maintenance of late includes the degradation of the rainwater goods, and means that any repair work will be extensive and very costly.

*Figs 12: view along veranda*

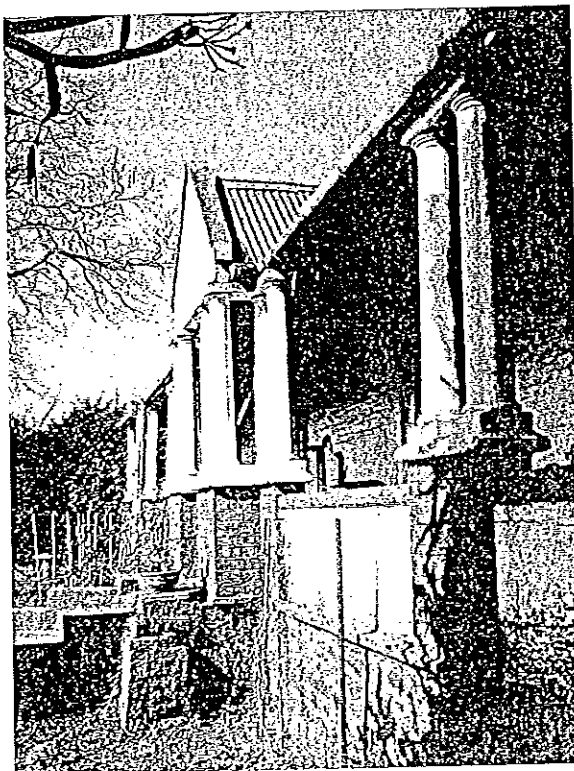
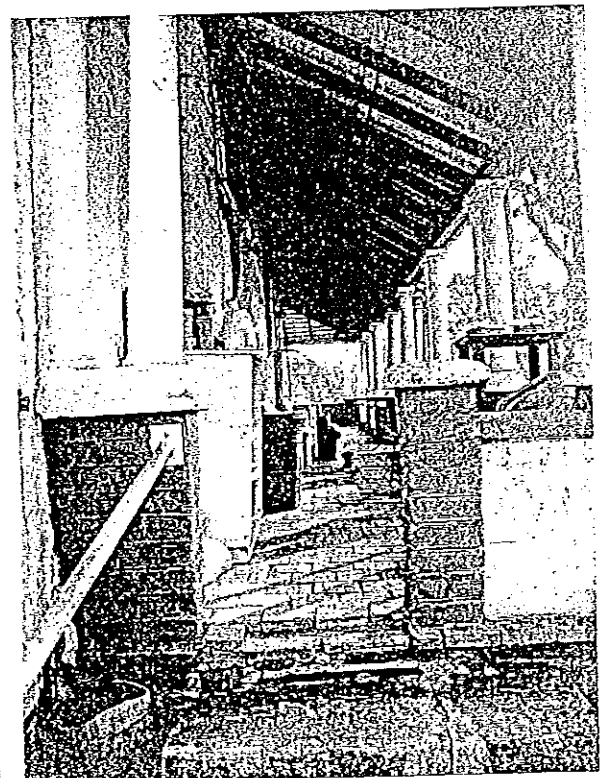
*Fig 14: view showing forward pitching pediment Fig 15: view along veranda from east*

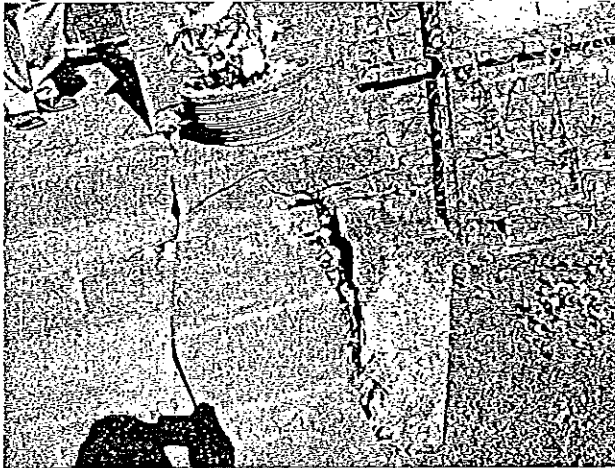
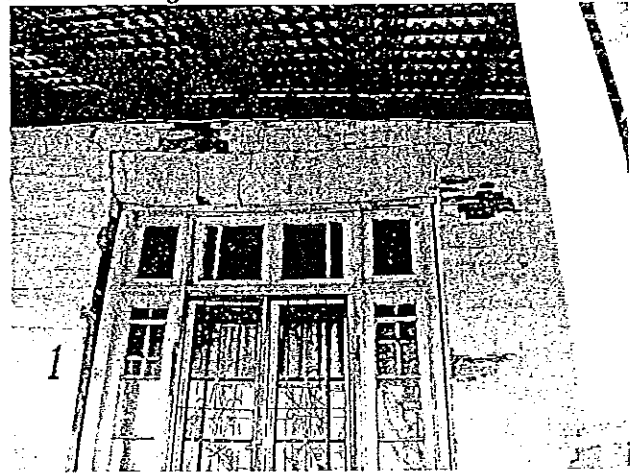
*Fig 16 & 17: structural collapse: main stairs, and lintol over French doors, both on veranda*

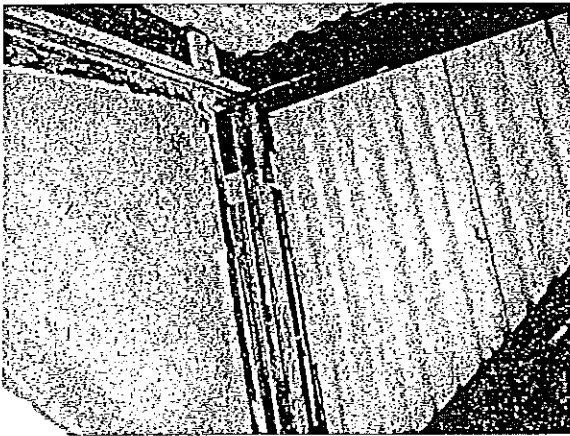
*Fig 18: showing pediment and space created through rotational movement*

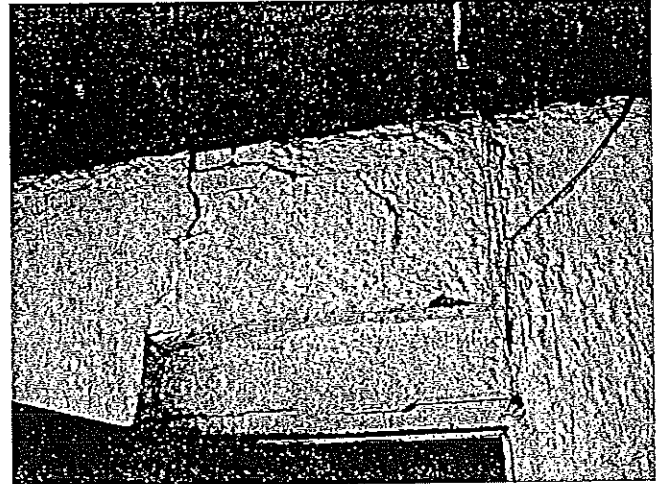
*Fig 38: collapsing arch into kitchen*

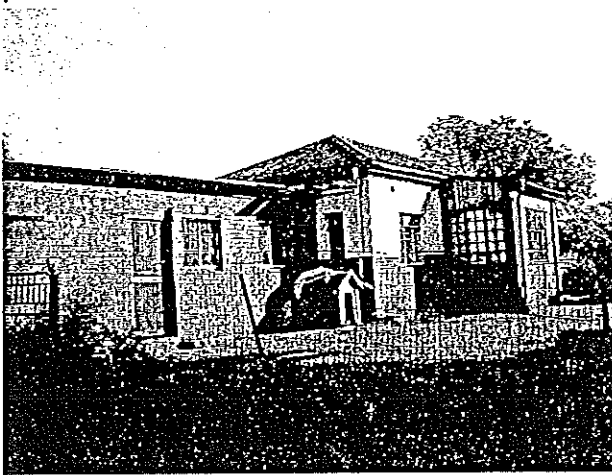
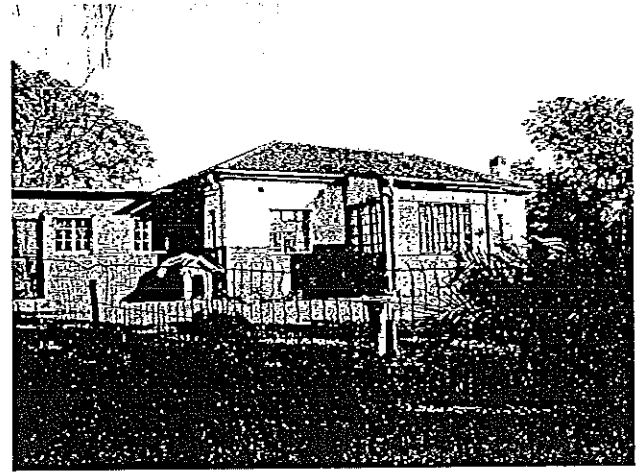
This is a serviceable building constructed in the 1940's to house Mr. Mill's grandparents. It is orthogonal under an asbestos sheet roof with steel windows. It has a couple of accretions, not the least a mixed material addition of recent construction.

*Figs 42 and 43: the 'cottage' from the south*

The 'cottage' is of solid construction and functional. It has little else to recommend it, and the author considers demolition and option.

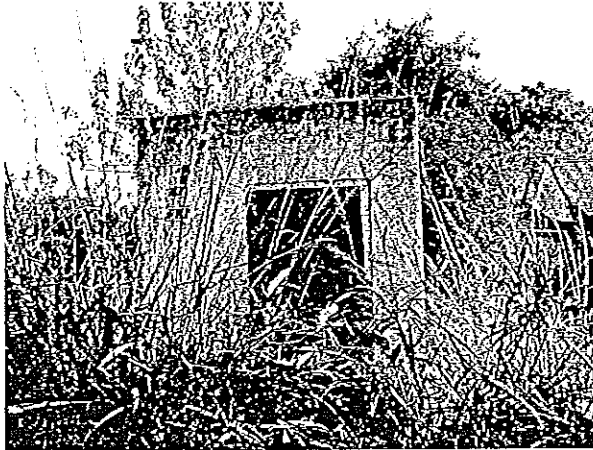
This small structure adjoins Blackburrow Road. It has a flat concrete slab roof, as this had tanks on top of it. Below and in front of the door to the dairy is an old well. (see fig 47)

*Fig 46: the dairy*

The dairy is of solid construction and functional. It has little else to recommend it. The author considers demolition an option.

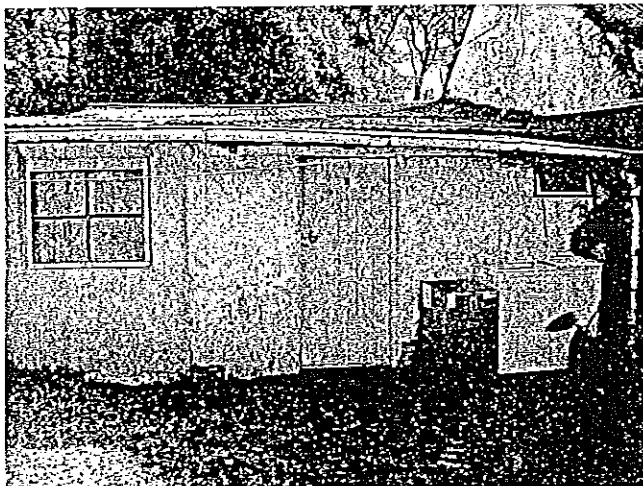
This is dealt with separately as it is an addition to the main house which could be removed if the main building was to be retained. It is of incremental construction, has had little thought to the planning, and in the opinion of the author could be demolished.

*Fig 49: the coal shed*

There is little to recommend in retaining this addition and the author recommends demolition
